# Hydrothermal monitoring using embedded sensors of the actual roof system of the Prado Museum

J. Sanchez \*, C. Andrade, J. Fullea

*Institute of Construction Sciences "Eduardo Torroja" (IETcc) – CSIC, Serrano Galvache 4, 28033 Madrid, Spain*

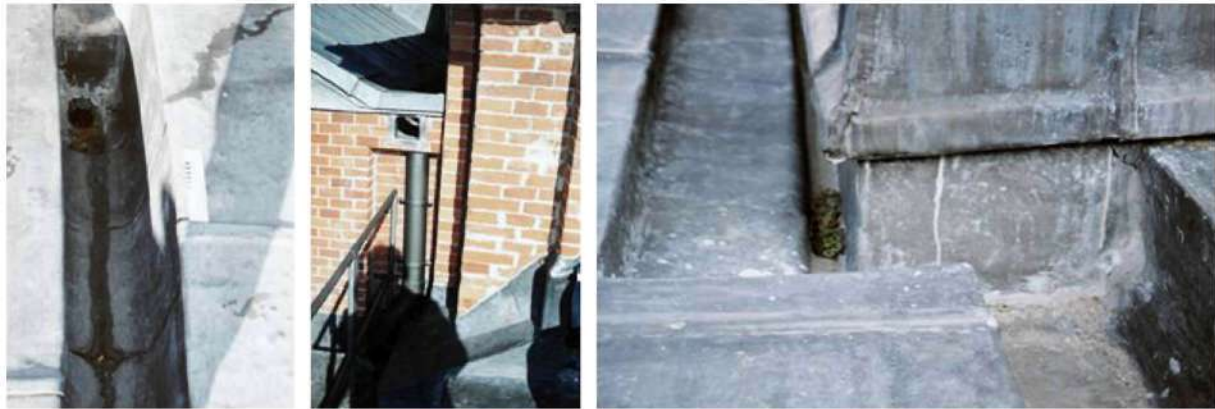
The event was explained due to the lack of enough evacuation ability of the draining horizontal and vertical pipes (Fig. 5) because of the enormous amount of water dropped during the storm. Due to the small inclination (although fulfilling the standards) of the roof and the large surfaces (of around 1100 m<sup>2</sup> in the zone of the leaking) of the roof (Figs. 1 and 2), the water is accumulated after

Fig. 5. The draining horizontal and vertical pipes.

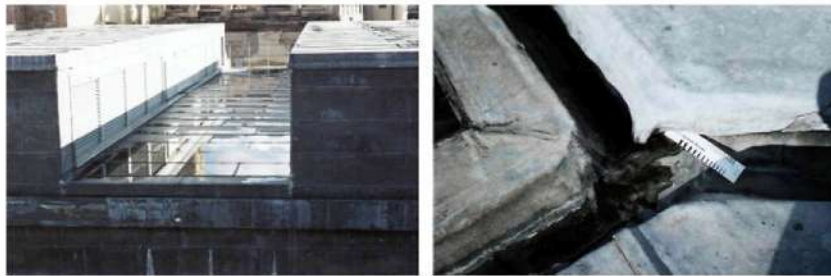
a rain event, even not important (Fig. 6 left taken during one inspection), and therefore could not be evacuated with enough speed remaining as scattered "ponds" during certain hours all around the roof. In addition, during the exhaustive inspection there were found some local execution defects (Fig. 6 right) that were statistically feasible due to the extraordinary complexity of the

Fig. 6. Left: water "ponds" scattered detected on the roof after a normal rain event. Right: execution defect in a singular point were cracks in one of the mortar layers and in the rubber were found.

roof with numerous singular and intersections points. In summary, the leaking was attributed to the generation of a local pond due the lack of section of the draining pipes for evacuation of the rain dropped, with the simultaneous coincidence of a local defect found in the waterproofing coat at the border of the skylight affected.

It is not the aim of present paper to describe all the details of the reasons of the leaking but to justify the recommendation of the continuous monitoring system installed and of the recommendations made to improve the tightness and water evacuation ability of the roof. The roof was exhaustively inspected and all execution defects found were repaired (Fig. 7). The inclination of the roof was increased in certain zones and the vertical draining pipes were increased. As part of the repairing a monitoring system of the roof tightness was proposed and accepted. No new leaking event has been detected since then.

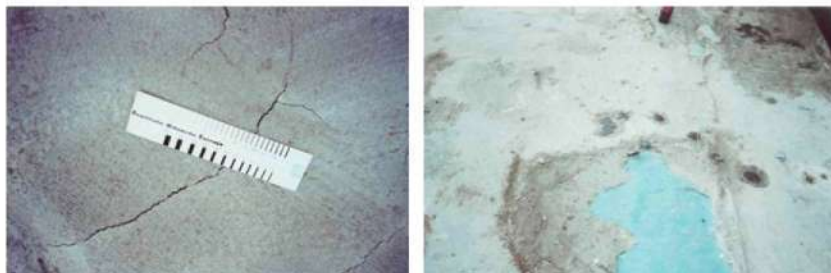
Fig. 7. Roof defects repaired.

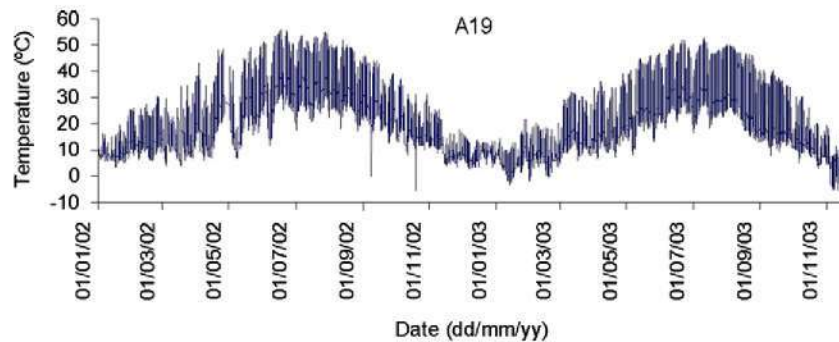
Fig. 11 presents the complete record of *temperature* readings for one of the two sensors located below the lead layer. The graph plots the annual temperature cycles and daily variations. This is the position that records the widest temperature variations, exceeding 50 °C in summer and dropping below 0 °C in winter.

**Fig. 11.** Temperature sensor A19, located in position 1 and on layer 9.

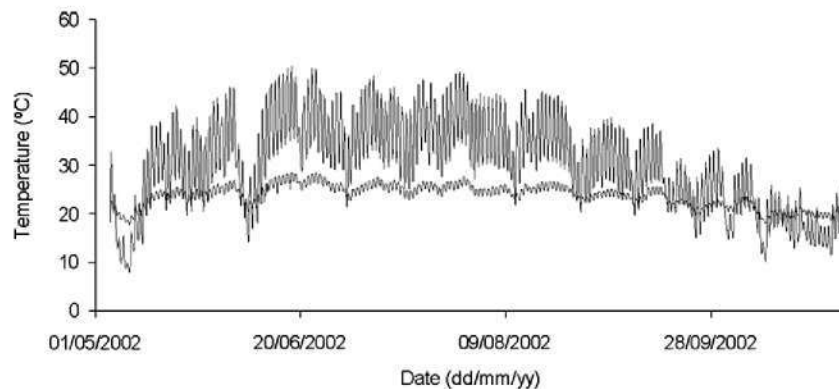
Fig. 12 shows the temperature variation in two sensors located at different heights. Whereas the sensor closest to the roof surface records major daily variations, the sensor that has been embedded the furthest down (A01) remains almost constant.

**Fig. 12.** Comparison of the temperature at two different depths. A01 and A15 temperature sensors.

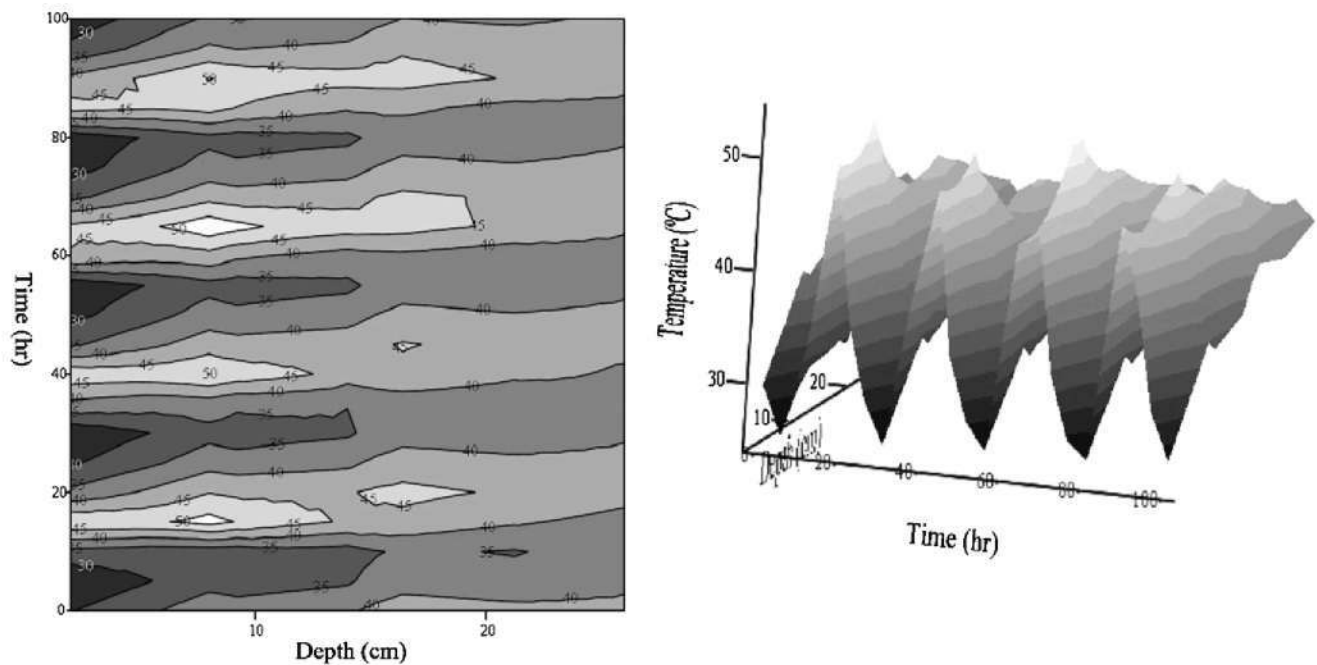
Fig. 13 plots the temperature readings recorded by all *temperature* sensors against time and depth. The sensors closest to the surface record a large temperature variation due to ambient temperature variations and sunlight, whereas the further down embedded, shows the smaller variations in temperature. These parameters indicate that the refurbishment work has been performed correctly with proper insulation.

**Fig. 13.** In the left is given temperature gradient with depth of the roof. Daily variations. In the right is shown these variations with their evolution in time.

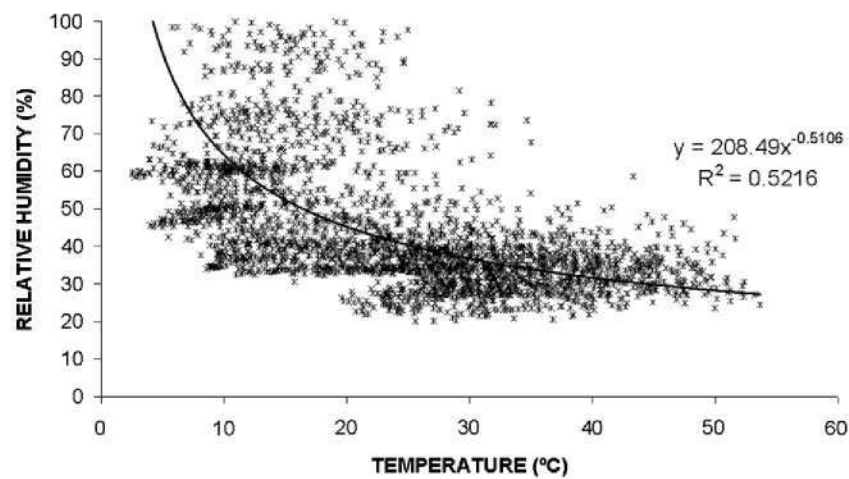
The recording of the RH values is depicted by Fig. 14. As reported in [25], the relative humidity inside concrete may remain at values above 60% during long periods, which means that condensation may appear in certain places, such as, for example, between the floating waterproofing layer and the arlite mortar where it is noticed by the liquid water sensors.

**Fig. 14.** Relative humidity values obtained from the sensors and their relation to temperature.

Regarding water tightness, Fig. 14 shows the relative humidity values versus temperature. The roof behaves similarly to a closed system in which there is no incoming or outgoing humidity. The relative humidity drops as temperature increases, with absolute humidity, namely, the amount of water in the roof, remaining constant. This behaviour is not affected by periods of dry or wet weather. This confirms that not new water or vapour penetrates into the roof which then, maintains its tightness until present.

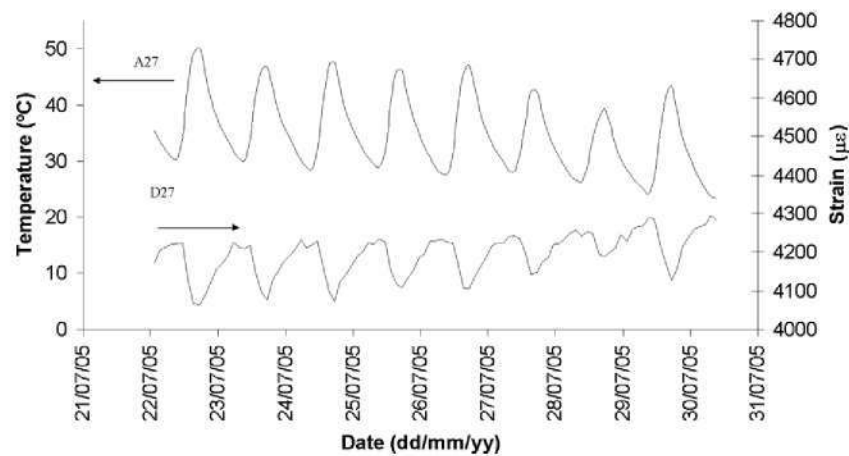
**Fig. 15.** Variation in the strain of the sealant plotted simultaneously to temperature.

Fig. 15 provides a detail of the daily variations in strain and the temperature reading of the sensor located besides the gauge. There is a dimensional variation in the waterproofing layer caused by changes in temperature. The absolute amplitude variation is around  $200 \mu\epsilon$ , that is, a strain of 0.02%, which is a very low figure,

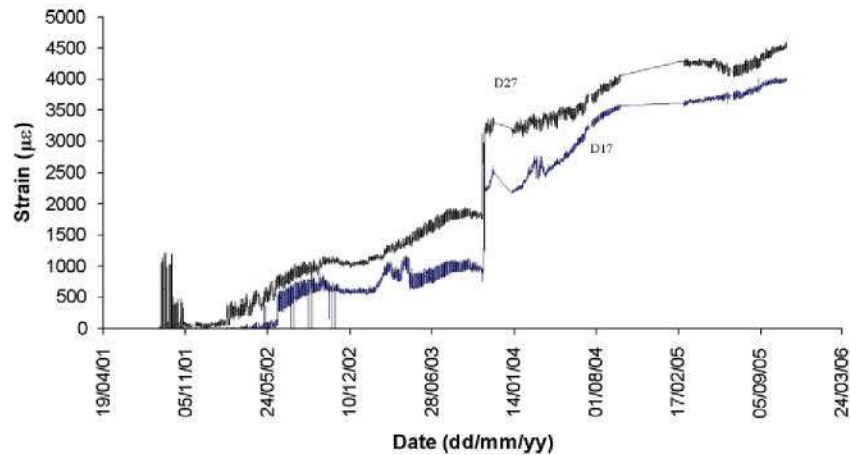
Fig. 16. Strain values recorded from strain-gages positioned in the sealant.

and even more so for a polymeric material. More important seems to be the permanent increase in strain that is depicted by Fig. 16. The gauges indicated certain cycles during their installation to further increase continuously with the time, as if the system is expanding. A vertical shift of the reading noticed at the end of

2003 has to be interpreted as due to a voltage jump due to the switching off-on for the downloading of the data occurred at that time. The further recording was logical if this shift is neglected, and then this sharp variation did not alter the recording.

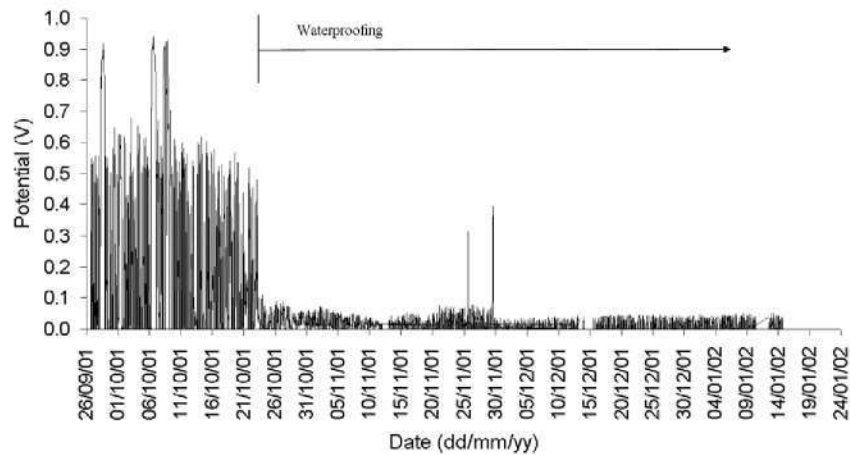
Fig. 17. Liquid water sensor showing at the beginning high changes in potential difference while these differences disappear when drying.

The liquid water sensors that have been installed in all the roof layers during its refurbishment were specially manufactured for this work. Fig. 17 presents the readings of one of the liquid water sensors during the period it was installed. This sensor was embedded in the liquid waterproofing until the floating waterproofing was put in place. It can be noticed through the initial high values of potential difference, how it detects the presence of water, as that exposure coincided with a period of rainfall, until the time when the floating waterproofing was installed, in which moment the potential difference decreased dramatically due to this last layer effectively isolated from the rain.

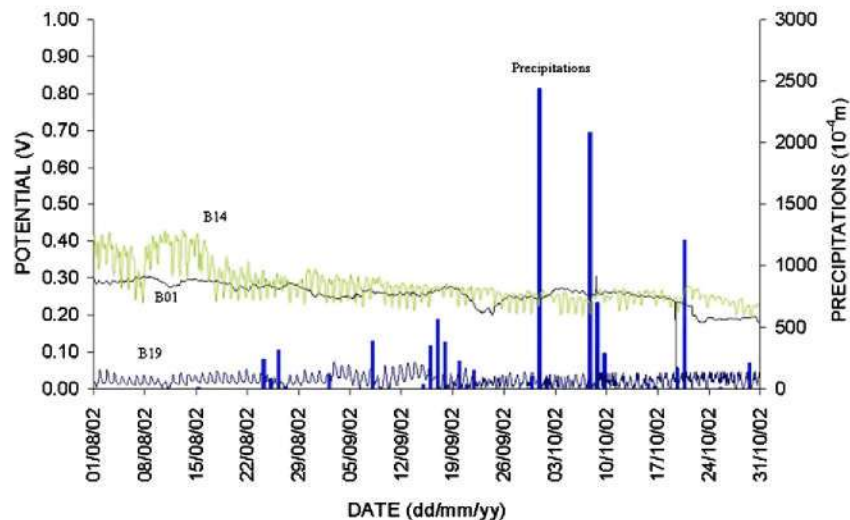
Fig. 18. Precipitations and potential difference given by liquid water detecting sensors.

Additional information is given in Fig. 18 which shows the rain precipitations and the behaviour of some liquid water sensors placed in different roof layers. In this example, the rain precipitations are not detected by the sensors. This is interpreted as the rain water does not ingress into roof layers being then the system operating as expected.

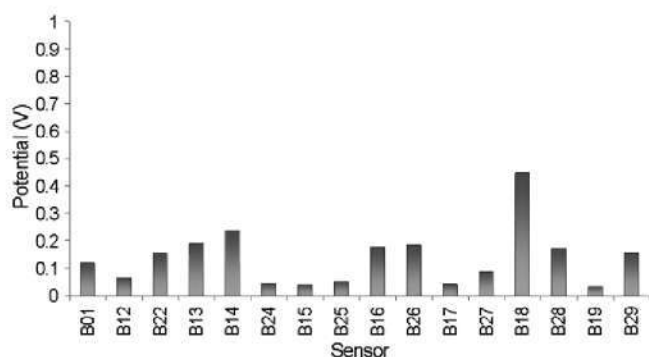
Finally Fig. 19 presents the average values recorded by the liquid water sensors. The values remain almost constant over the four years of registering. All the sensors record potential values below 0.8 mV, that is, they do not detect the presence of liquid water

Fig. 19. Averaged value of the potential difference of the liquid water detecting sensors during the 4 years.

inside the roof at any of its layers. The different value readings between the sensors are due to their positioning. The sensors placed in contact with the mortar have a higher potential difference than all the other sensors. This was interpreted to be due to the relative humidity within the cementitious mortar is higher, which may cause condensation in certain places when the temperature lowers.

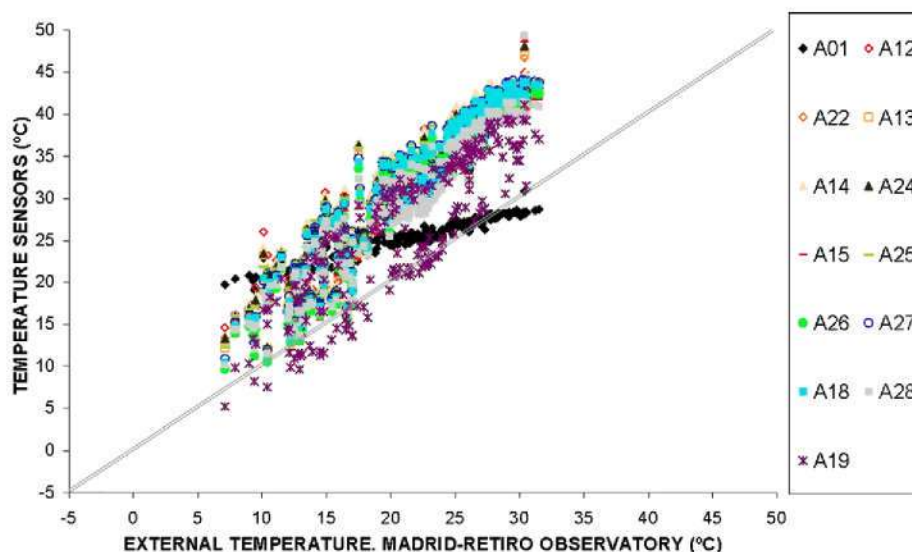
Fig. 20. External and sensor roof temperatures.

With respect to the *thermal behaviour* of the roof, in Figs. 11–13 the temperatures are plotted with respect to the roof depth and the time. Better appreciation is possible in Fig. 20 where external and roof temperatures are compared. It is necessary to remark that in general the temperature of the roof is higher than external temperature, being around until 15 °C higher than the external temperature. This phenomenon is interpreted to be caused by solar radiation and thermal hysteresis due to the lead cover which stores the heat and provokes its slow release. However when penetrating into the most internal roof layers the temperatures decrease significantly although and the temperature in the most interior layer remains stable and around 20 °C (Figs. 12 and 20) which is indicative that the roof is isolating from the external temperature changes and is damping the thermal charge. Contrary, the internal temperature of the roof is higher than the exterior in winter, when the external temperature is almost 0 °C and the internal temperature remains in about 20 °C.
